September 2, 2003

TO: Minerals File  
SUBJECT: Site Inspection, Geokinetics, Seep Ridge Mine, S/047/002, Uintah County, Utah

# Seep Ridge Mine M/047/001

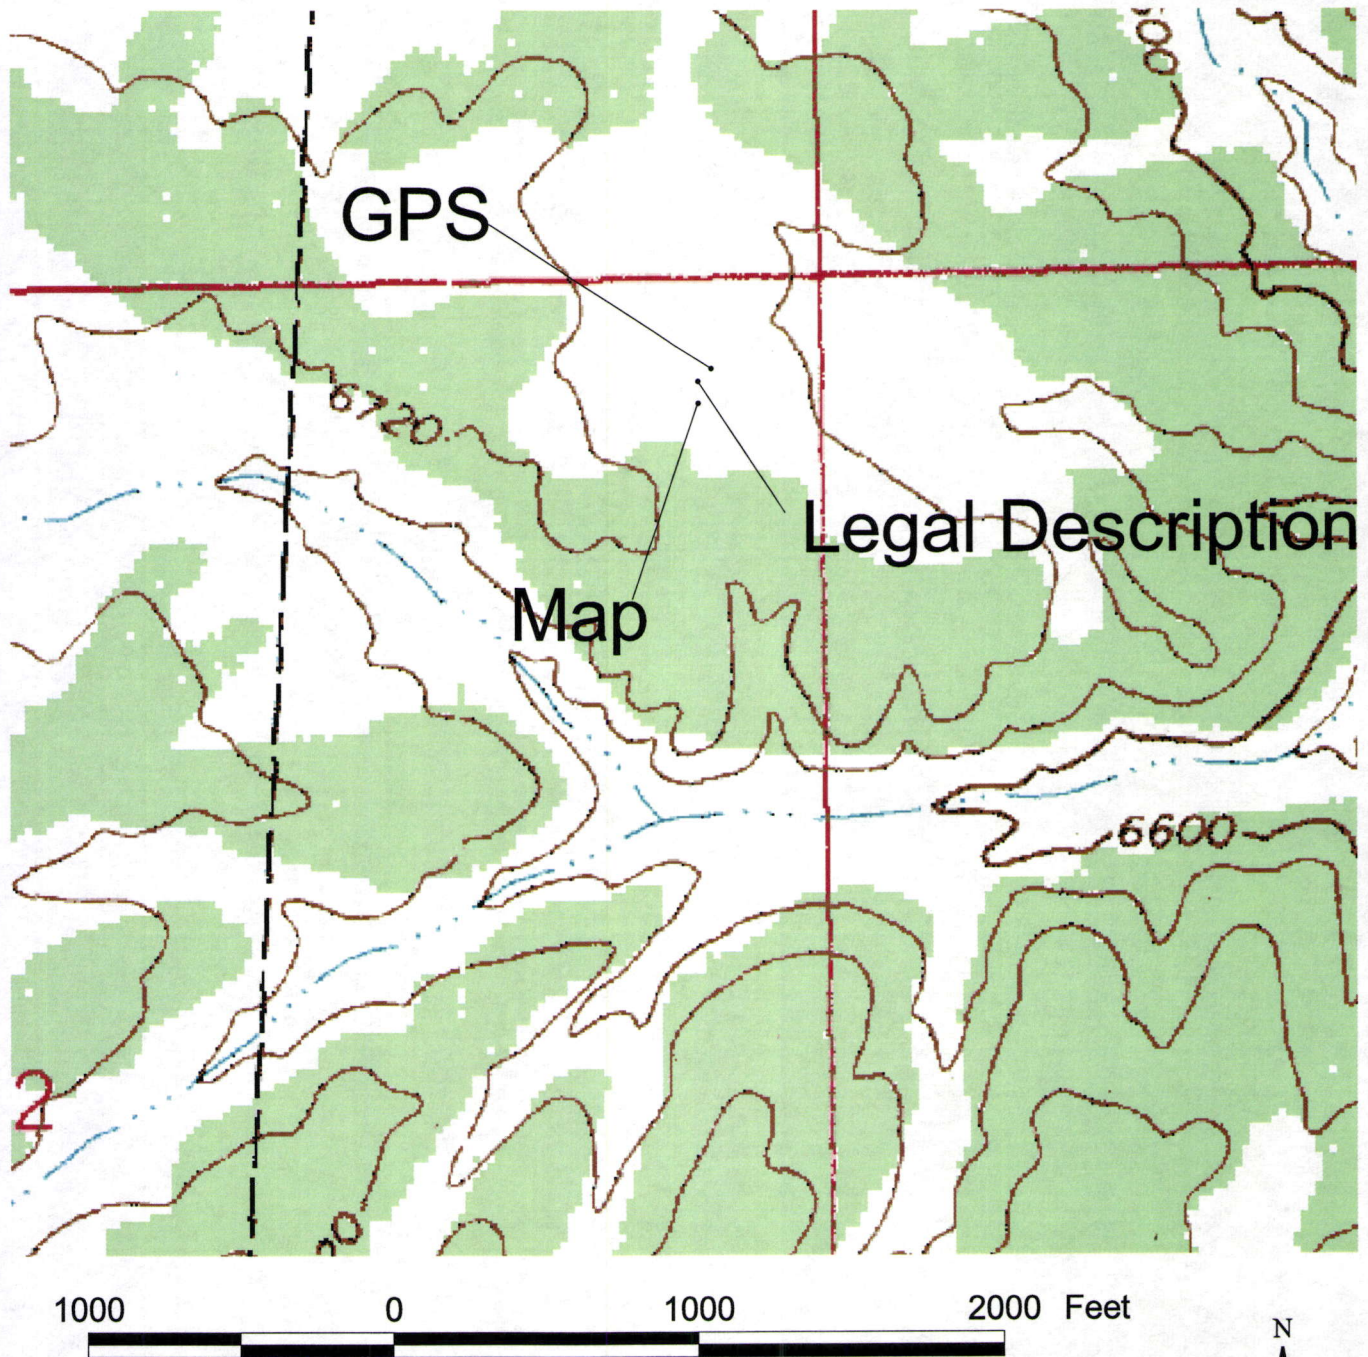
During the previous inspection, I took a GPS point at the place where I think the well might be. Attached to this report is a map showing this GPS location. I also plotted the location of the well based on the legal description in the associated water right and according to a map in the mine plan. Although the points appear very close on the map, the point plotted from the legal description and the point based on the mine plan map are actually about 80 feet apart.

Possible locations of a water well in the Seep Ridge Trailer Park area. These locations are based on the water right legal description, measurements from a map in the mine plan, and GPS coordinates of the possible well location. Bates Knolls Quadrangle, Section 2, Township 14 South, Range 22 East, SLBM.

The operator intends to have a backhoe come out and dig up the culvert. We suggested that at the same time, the backhoe operator could dig and try to find the well casing.
